# **Supplemental Watershed Plan-Environmental Assessment for the Pohick Creek Watershed**

Supplement No. 5 to the original watershed plan for the rehabilitation  
of Pohick Creek Dam No. 2 (Lake Barton)

Fairfax County, Virginia

August 2009

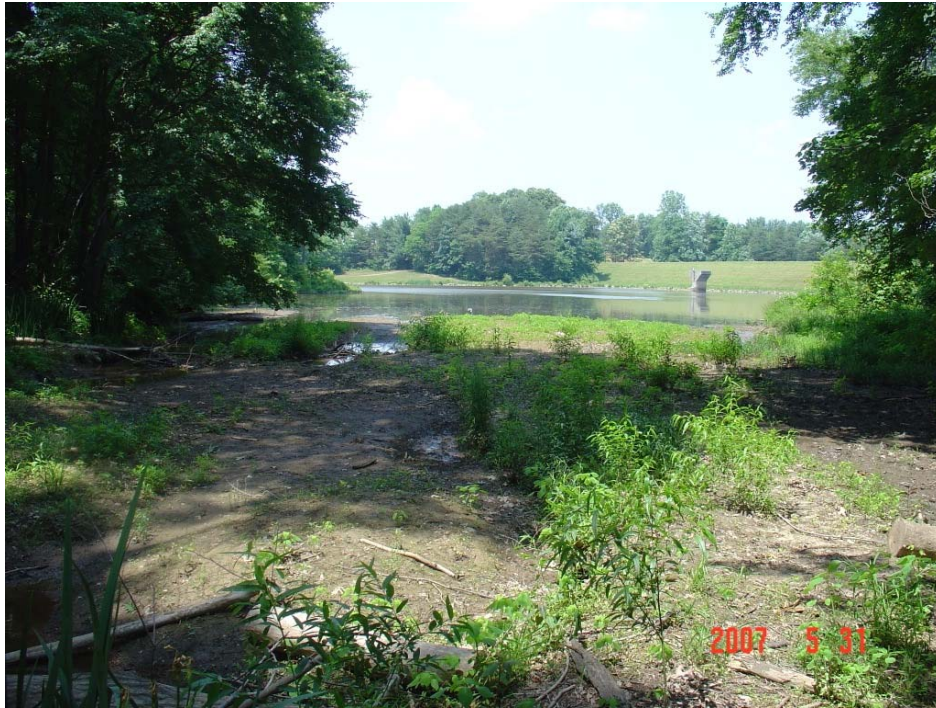
**Figure 1.** Sediment deposited in southern arm of Lake Barton.

Erosion and Sedimentation: As of 2007, Lake Barton had reached about 29% of its planned service life. According to the 2007 sediment survey conducted of the lake, the volume of sediment (both submerged and aerated) in the Lake Barton reservoir and its tributaries was about 37.8% of the original as-built sediment storage volume. Approximately 10.3 acre-feet of sediment were removed by dredging from 1985 to 1990. As expected, most of the sediment observed is present in the inlet channel areas of the structure. This material is primarily deposited sediments plus leaf and other organic debris. Figures 1 and 2 show the sediment accumulations in the lake.

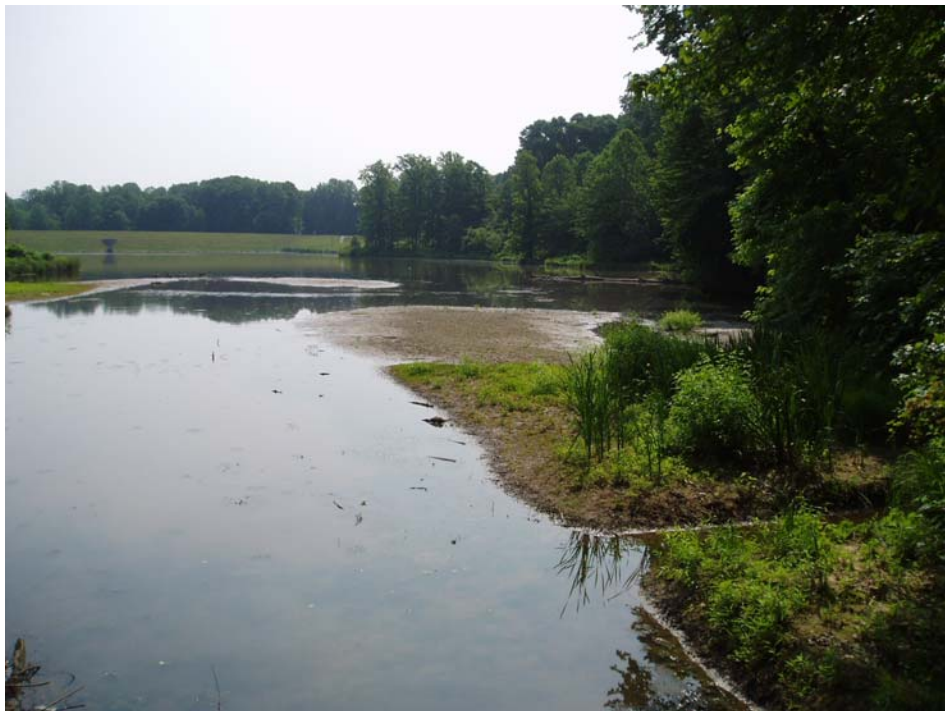
**Figure 2.** Sediment deposited in northern arm of Lake Barton.

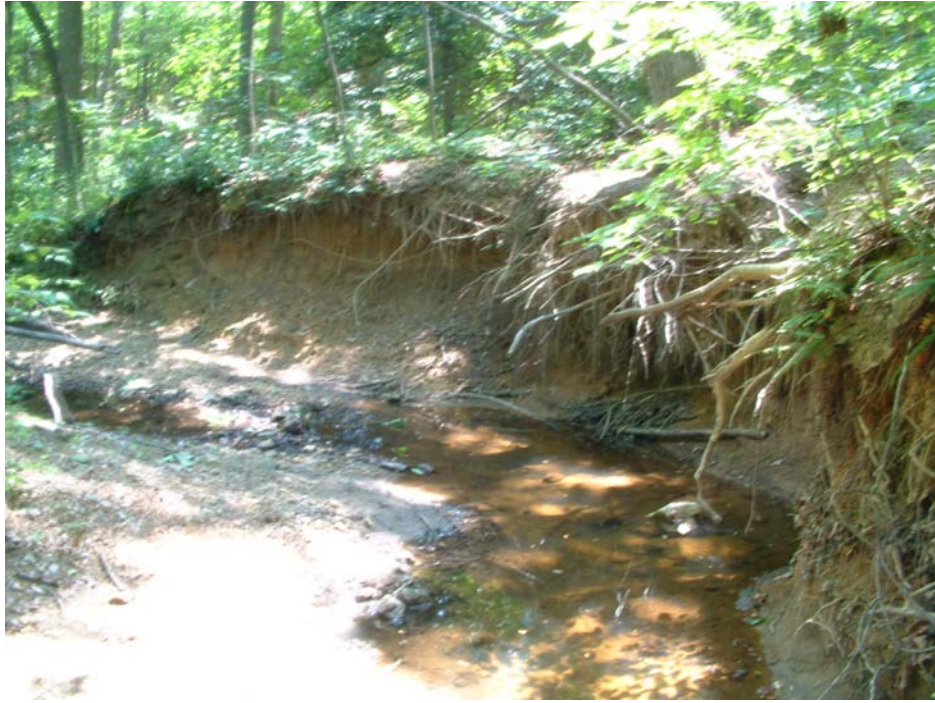
**Figure 3.** Streambank erosion upstream of Lake Barton.

In the original design, 463 acres of the watershed were classified as "subject to construction." Currently, 398.6 acres of the watershed are either classified as having a land use of 'Residential/Business' or 'Transportation', with the majority being Residential/Business. The watershed area is predominantly "built-out." The increase in impervious surface area has increased the volume of runoff into the streams feeding the lake. As a result, the stream banks have eroded, contributing sediment to the lake. Stormwater management, stream bank erosion control, and general watershed erosion control in the watershed are the responsibility of the sponsors and will not be addressed in this plan. Streambank erosion in the watershed is shown in Figures 3 and 4.

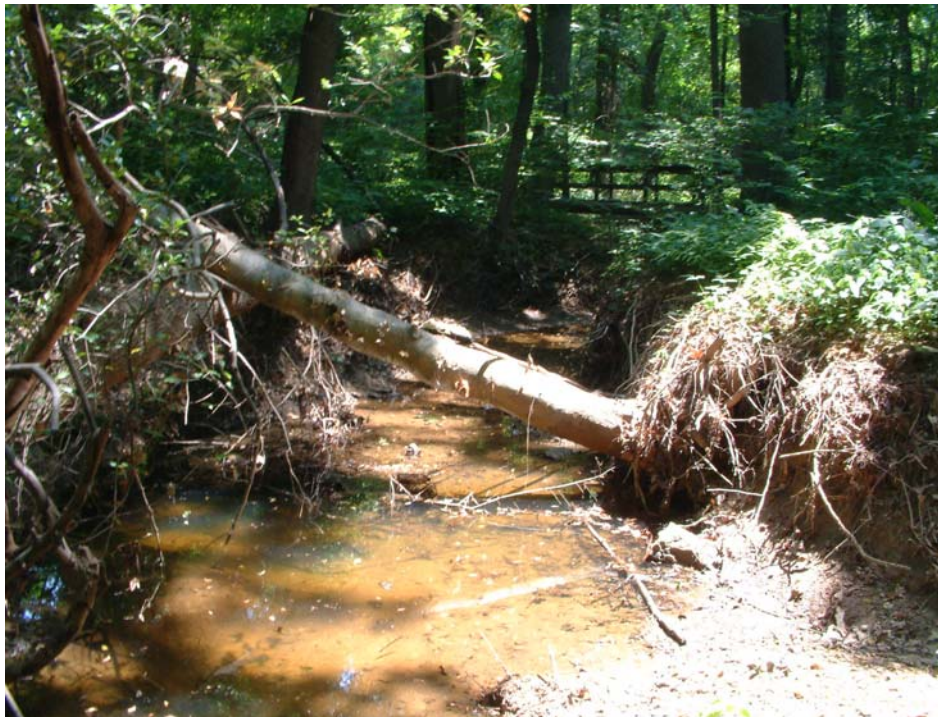
**Figure 4.** Streambank instability caused by streambank erosion upstream of Lake Barton.

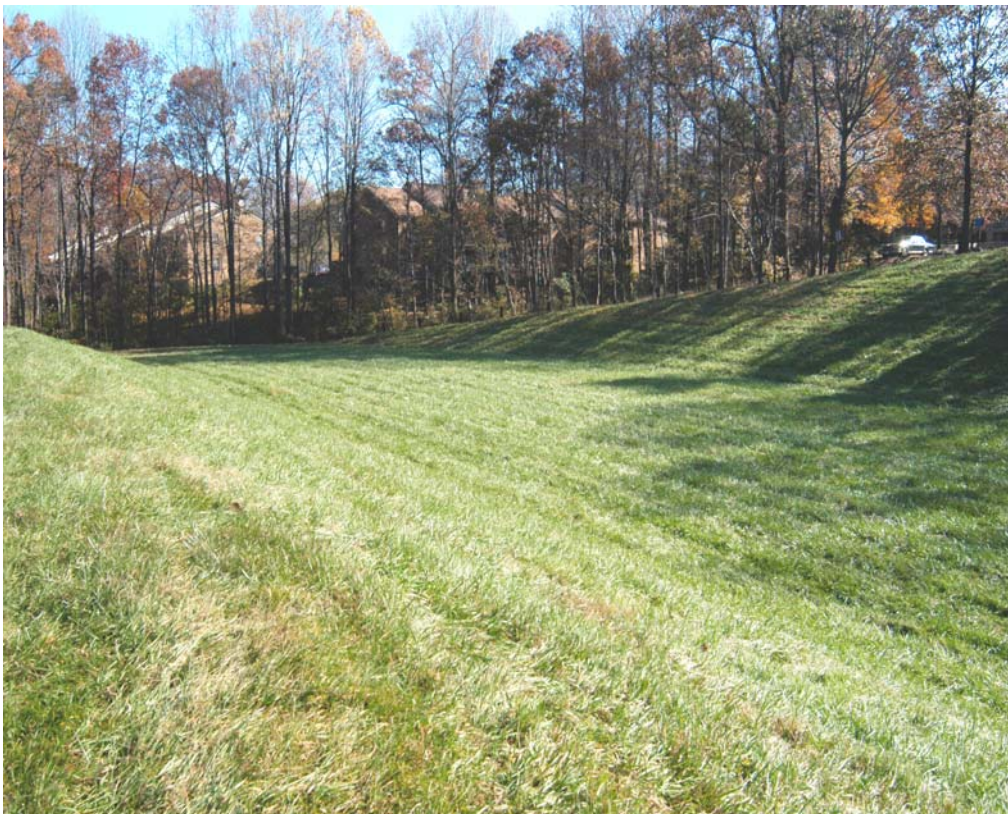
Figure 5. Existing auxiliary spillway.

Potential Dam Safety Deficiencies: The Virginia Division of Dam Safety issued a conditional use certificate for Pohick Creek Watershed Dam No. 2 because the vegetated earthen auxiliary spillway would not pass the Probable Maximum Flood (PMF) storm flow without breaching the structure. A minor deficiency noted in the AMT analysis is that the existing top of dam is about 0.4 feet low for the last 50 feet adjacent to the auxiliary spillway. This means that the training dike is also slightly low.
