Natural Resources Conservation Service

Marietta, OH Soil Survey Office

Investigation for Emergency Watershed Protection— Streambank Stabilization

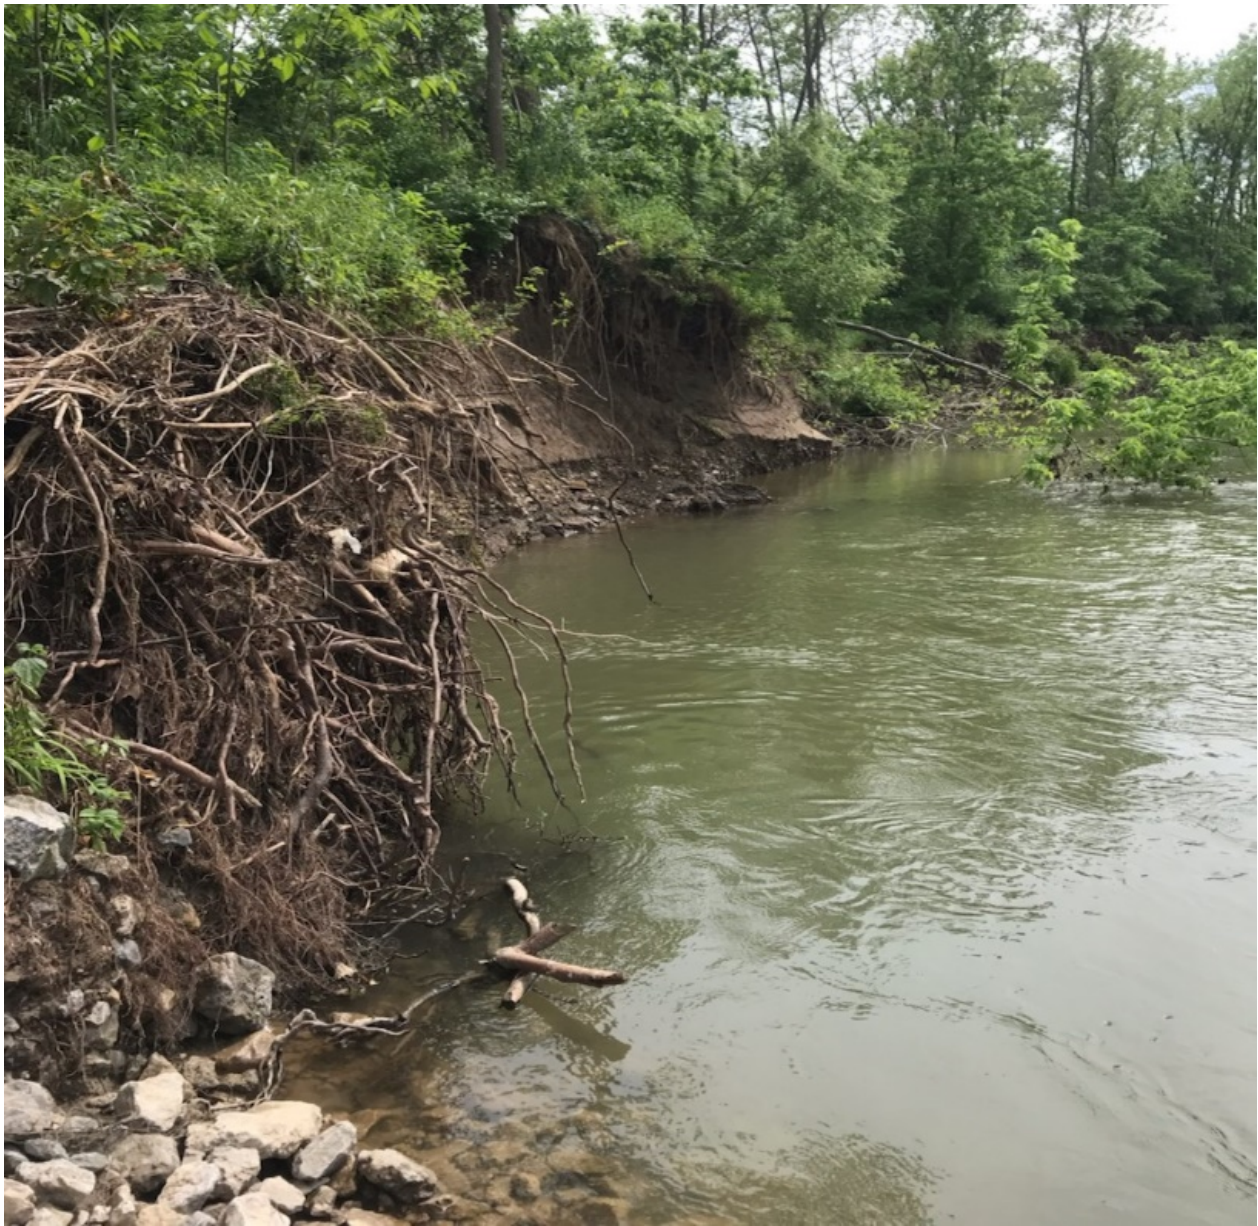
The Emergency Watershed Protection (EWP) Program offers technical and financial assistance to help local communities relieve imminent threats to life and property caused by floods, fires, windstorms, and other natural disasters that impair a watershed. The Pleasant Valley Sewer District, near Chillicothe, Ohio, contacted the Ross County NRCS Field Office requesting assistance for streambank erosion that has continued to endanger a sewer line that is routed under an area of the North Fork Paint Creek shown in Figure 1.

Figure 1. Streambank erosion immediately upstream from the recently repaired section of sewer line which crosses under North Fork Paint Creek.

The Area Engineer and the Area Resource Soil Scientist contacted the Marietta, Ohio Soil Survey Office for assistance with an investigation of the soil materials adjacent to the stream bank. The soils information would be used to determine the type of stabilization structure needed to protect the newly installed sewer lines. On July 1, 2020, Dan Benyei, soil scientist at the Marietta Soil Survey Office, met with Ohio NRCS Area 5 staff on site to complete two soil borings, over 15 feet deep, using a truck-mounted Giddings soil probe. Soil boring is a technique used by soil scientists to determine the soil properties. Based on existing soils information of the area, and the new soil samples, Dan was able to assist with characterization of the soil materials observed. The Area Engineer will use the information in the design of a suitable structure to address site and soil conditions.
