Dam Rehabilitation Fact Sheet

Mills Creek Dam, Augusta County, Virginia South River Dam No. 10A

September 2010

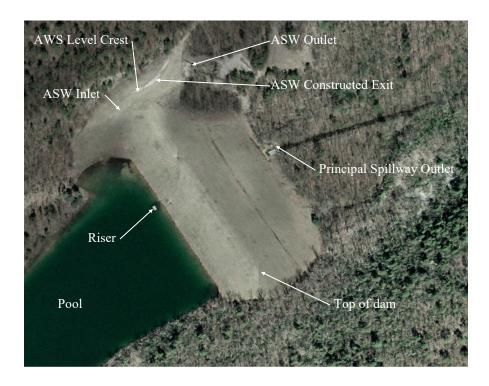
Aerial photograph of the Mills Creek dam (2007).

The Mills Creek dam was built in 1963 to provide flood control and water supply. At the time of design, this dam was considered to be a significant hazard dam due to the presence of roads and some isolated houses. Changes in land use have caused the hazard class of this dam to change to high. The design criteria is more stringent for a high hazard dam and the dam must be rehabilitated to meet the stricter requirements.

The dam stores flood water during storm events and gradually releases it into the stream over several days through the principal spillway pipe. At the present time, Mills Creek can store the runoff from about 8.4 inches of rain in 24 hours. Excess water that cannot be stored in the reservoir will pass through the grassy area at the end of the dam known as the auxiliary spillway. The principal spillway riser system regulates the water level in the dam and controls the rate at which the detained storm water is released from behind the dam.
