April 2015

## **Dam Rehabilitation Fact Sheet**

Huntsman Lake Dam, Pohick Creek Watershed

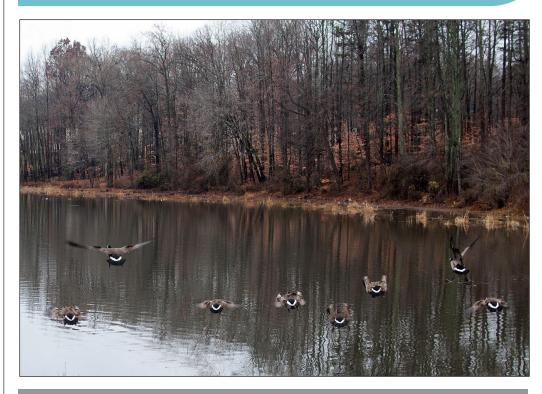
Wildlife have returned to the Huntsman Lake Dam after the lake was drained in the summer of 2014. The lake has also been restocked for local fishing. (Photo courtesy of Fairfax County)

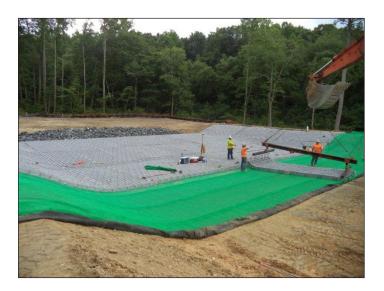
These articulated concrete blocks installed during construction are no longer visible to residents who walk the trails near the dam site.

To prevent erosion, the auxiliary spillway and the inside of the training dikes were lined with articulated concrete blocks that are cabled together. These blocks were completely covered with soil and vegetated with grass. After construction, the areas not covered with grass were planted with trees.

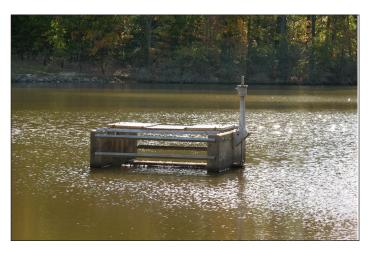
The open spillway riser (above) was replaced to improve public safety and prevent clogging from floating debris.

- Realigning the auxiliary spillway to protect the sanitary sewer;
- Armoring the auxiliary spillway and training dikes with articulated concrete blocks;
- Extending the training dikes to the valley floor to protect the dam embankment; and
- Replacing the principal spillway riser.
